Mortar deterioration of the masonry walls in historic buildings. A case history: Vanvitelli's Mole in Ancona

The utilization of data from advanced techniques, such as enhanced pattern treatment of x-ray diffraction analysis, combined with data from historical sources as well as environmental information, has been applied to diagnose the complex deterioration mechanism of a historic construction. A case history is provided dealing with a famous Italian construction in Ancona designed and erected by the Neapolitan architect Luigi Vanvitelli during 1733–1743, where both jointing and rendering mortars deteriorated very seriously. It has been found that the original lime–pozzolan mortar deteriorated due to physical events (rain water leaching, thermal changes, freezing–thawing, etc.), whereas Portland cement mortars, used to repair damaged walls, deteriorated by chemical sulfate attack.

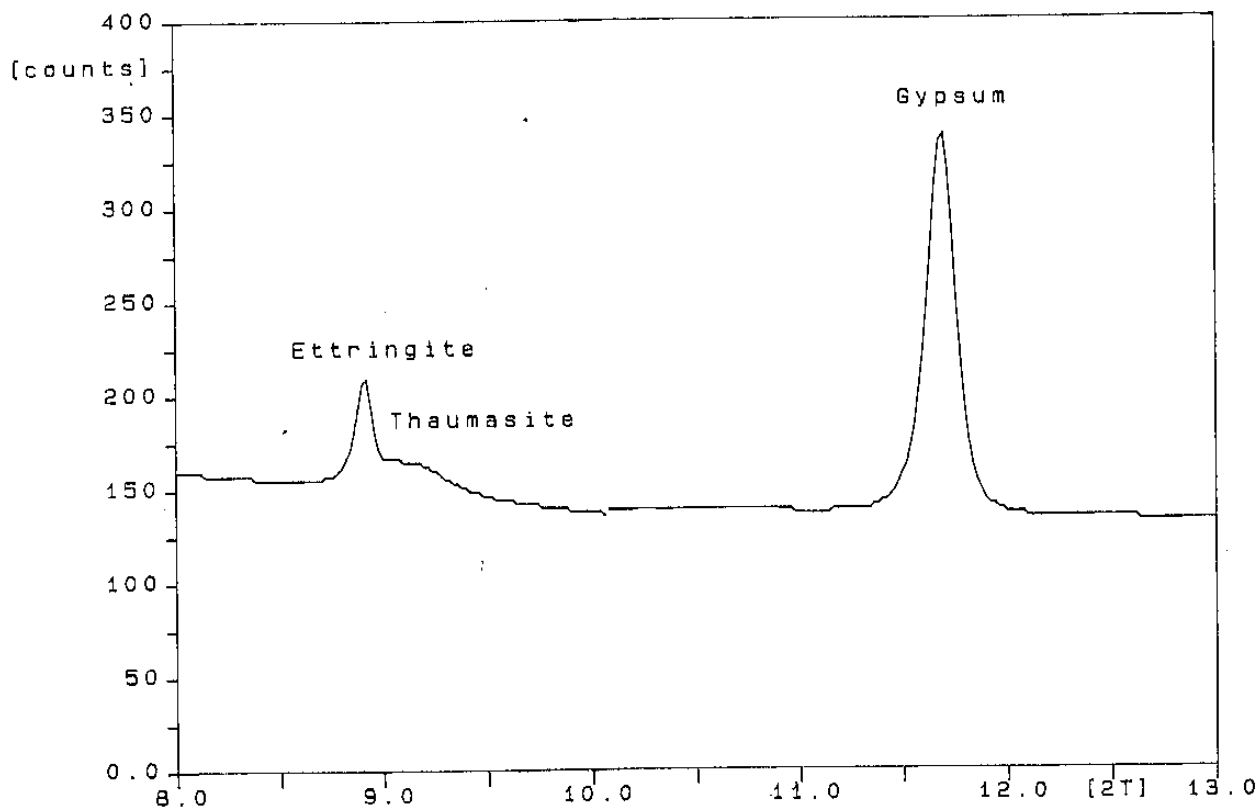
Moreover, detectable traces of ettringite and thaumasite, as well as a significant amount of gypsum, have been found in all the available samples of this repairing jointing mortar (Fig. 7). Gypsum production, and its subsequent transformation into ettringite ($\text{C}_3\text{A} \cdot 3\text{CaSO}_4 \cdot 32\text{H}_2\text{O}$) and thaumasite ($\text{CaSO}_4 \cdot \text{CaCO}_3 \cdot \text{CaSiO}_3 \cdot 15\text{H}_2\text{O}$):

Fig. 7 Treated XRD pattern of Portland cement based mortar sample to repair consumed facade jointing mortar.

could be ascribed to the formation process 2. Potential sulfate ion sources are (a) sulfate salts from bricks and (b) sea water capillary suction. In addition to these sources, gypsum could be formed by sulfur dioxide oxidation and subsequent sulfation of calcite [5–7], which is present both in the cement paste and in sand:

Therefore, in the repair mortar of Vanvitelli's Mole, all the three requirements for ettringite and thaumasite production [2] have been documented in the present work: (a) calcium aluminate or silicate hydrates produced by hydration of Portland cement used to repair the surface of jointing mortars; (b) gypsum formation by reaction of environmental SO_2 with lime; and (c) presence of water produced by sea water capillary suction or capillary condensation of water vapour in humid air.

crystallization, etc., appear to be responsible for the deterioration of this mortar. A Portland cement based mortar has been used in the past to repair the deteriorated jointing mortar as well as the rendering mortar. This repairing mortar appears to have been damaged by ettringite/thaumasite formation, as local humidity and sulfate sources are available to react with calcium aluminate/silicate hydrates produced by Portland cement hydration. Environmental SO_2 appears to be the main source of sulfate salts in addition to those coming from brick impurities or sea water capillary rise. For future repair work, cementitious materials should be tested and proved to be resistant to sulfate attack before their utilization in this historic building.

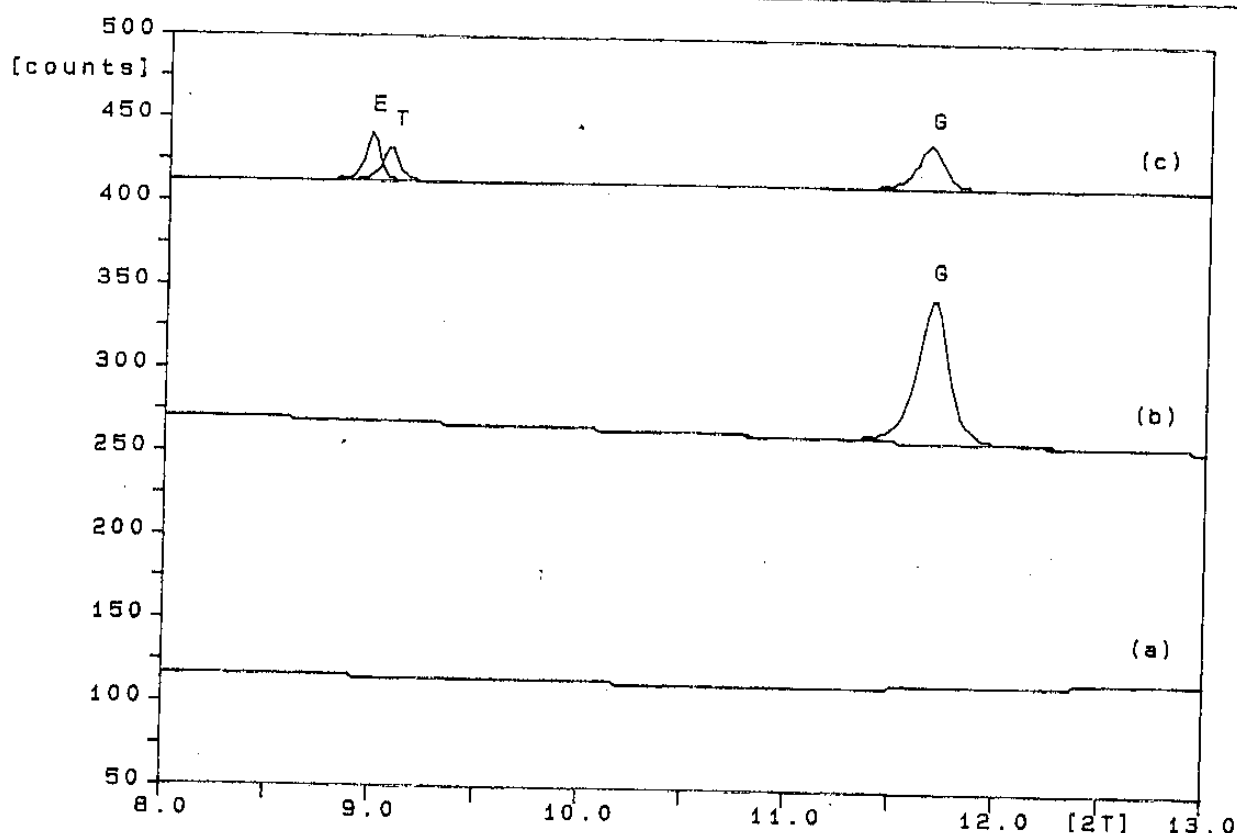
By XRD analysis, the five samples of rendering mortars have been separated into two types: (a) three samples based on lime-pozzolan mixes which do not contain any trace of gypsum, ettringite and thaumasite (Fig. 8a); and (b) two samples based on Portland cement mixes with traces of C_3S , C_2S , C_3A and C_4AF still present. In these

Fig. 8 Treated XRD patterns of three rendering mortars: A, without gypsum and ettringite or thaumasite; B, only gypsum (G); and C, gypsum (G), ettringite (E) and thaumasite (T).

two samples, two different situations have been found: in one sample a significant amount of gypsum is present without ettringite/thaumasite (Fig. 8b); in the other sample a significant amount of ettringite/thaumasite is present with a lower amount of gypsum (Fig. 8c). In the latter, it can be assumed that reactions 3 and 4 occurred, for some reasons, to a much higher extent than in the former: for instance, local humidity could have been higher in one area of the rendering mortar than in the other one, so that the degree of gypsum transformation into ettringite or thaumasite has been controlled by the local availability of water in the rendering mortar.
